Huntington BRO 1445(35)
Bridge 30 on TH 22 (Camels Hump Road)
Over Brush Brook
Alternatives Presentation

EXISTING BRIDGE DEFICIENCIES

Alternatives

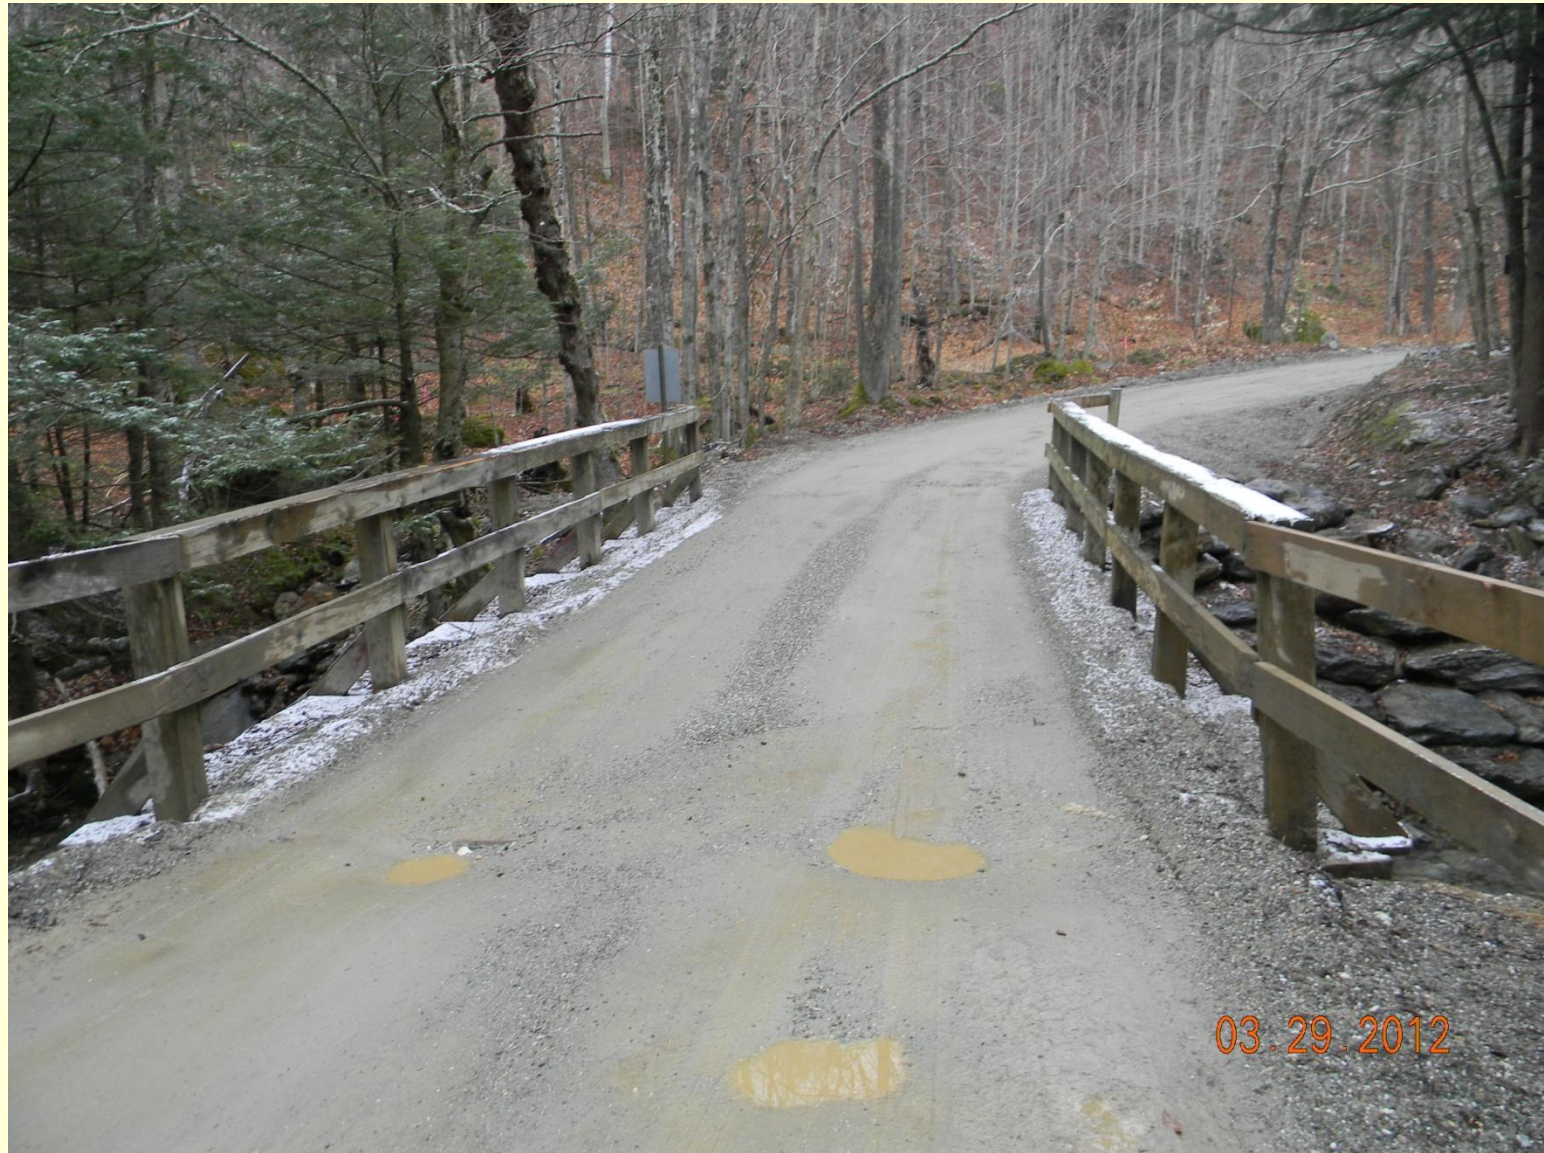
Bridge Width and Railing Issues

- The bridge width is substandard
- The bridge does not have adequate hydraulic capacity and has scour issues
- The bridge and approach rails do not meet the current standard

- Bridge Width (Face-Face Rail) = 12.5'
- Design Speed Limit = 20 mph (Posted speed)
- Posted for 16,000 weight limit (timber deck)

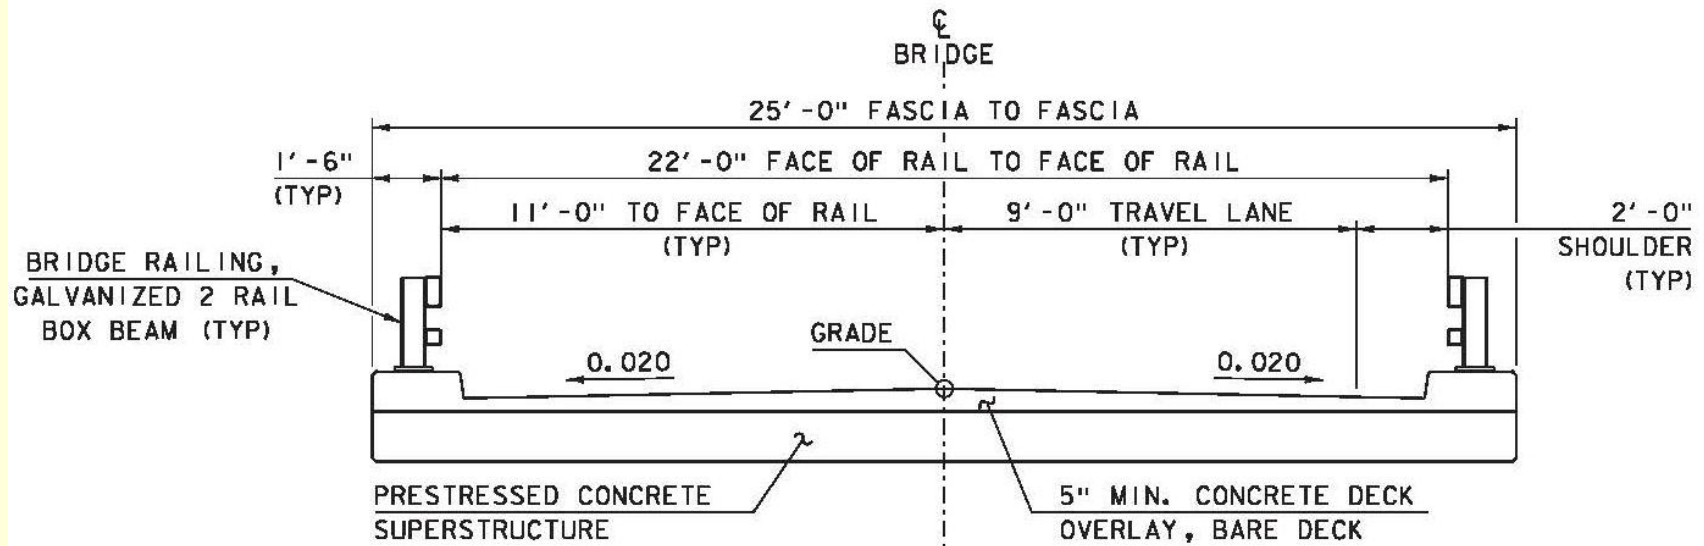
Alternative 3 – Typical Section

- Completely new bridge
- Width would meet required standards
- Alignment improved slightly (flatter curves)
- Longer span to address hydraulic issues
- Long term (80 year) solution
- Use phase construction to maintain traffic-

PROPOSED BRIDGE TYPICAL SECTION
